KSC Ice/Frost/Debris Assessment For Space Shuttle Mission STS-29R

Charles G. Stevenson
NASA/Kennedy Space Center

KSC ICE/FROST/DEBRIS ASSESSMENT
FOR
SPACE SHUTTLE MISSION
STS-29R
MARCH 13, 1989

Approved:
April 30, 1989

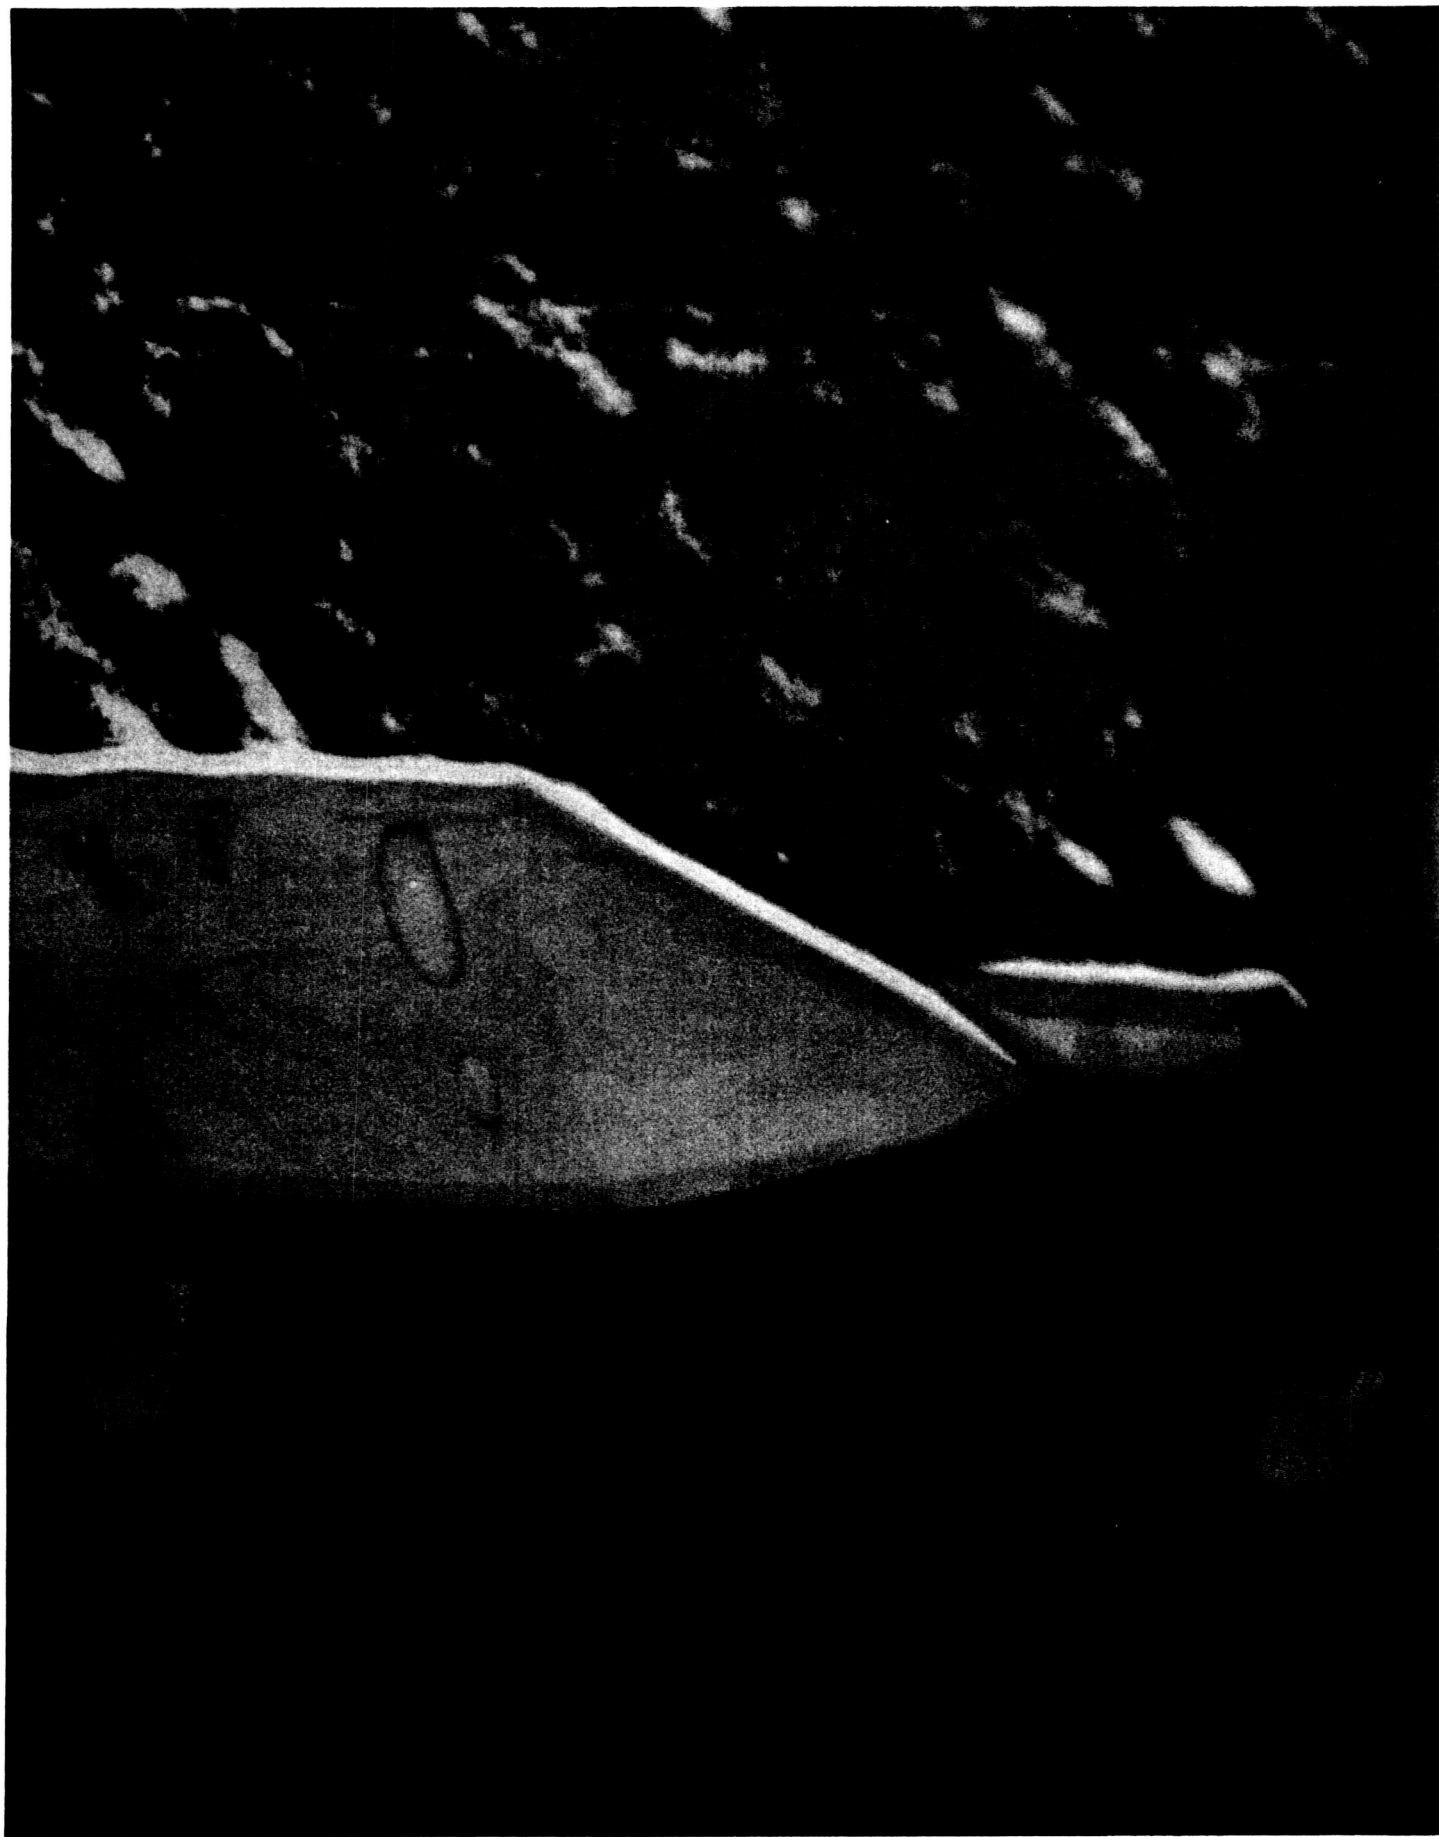
AN ICE/FROST LINE HAD FORMED ALONG THE PAL RAMP INTERFACE

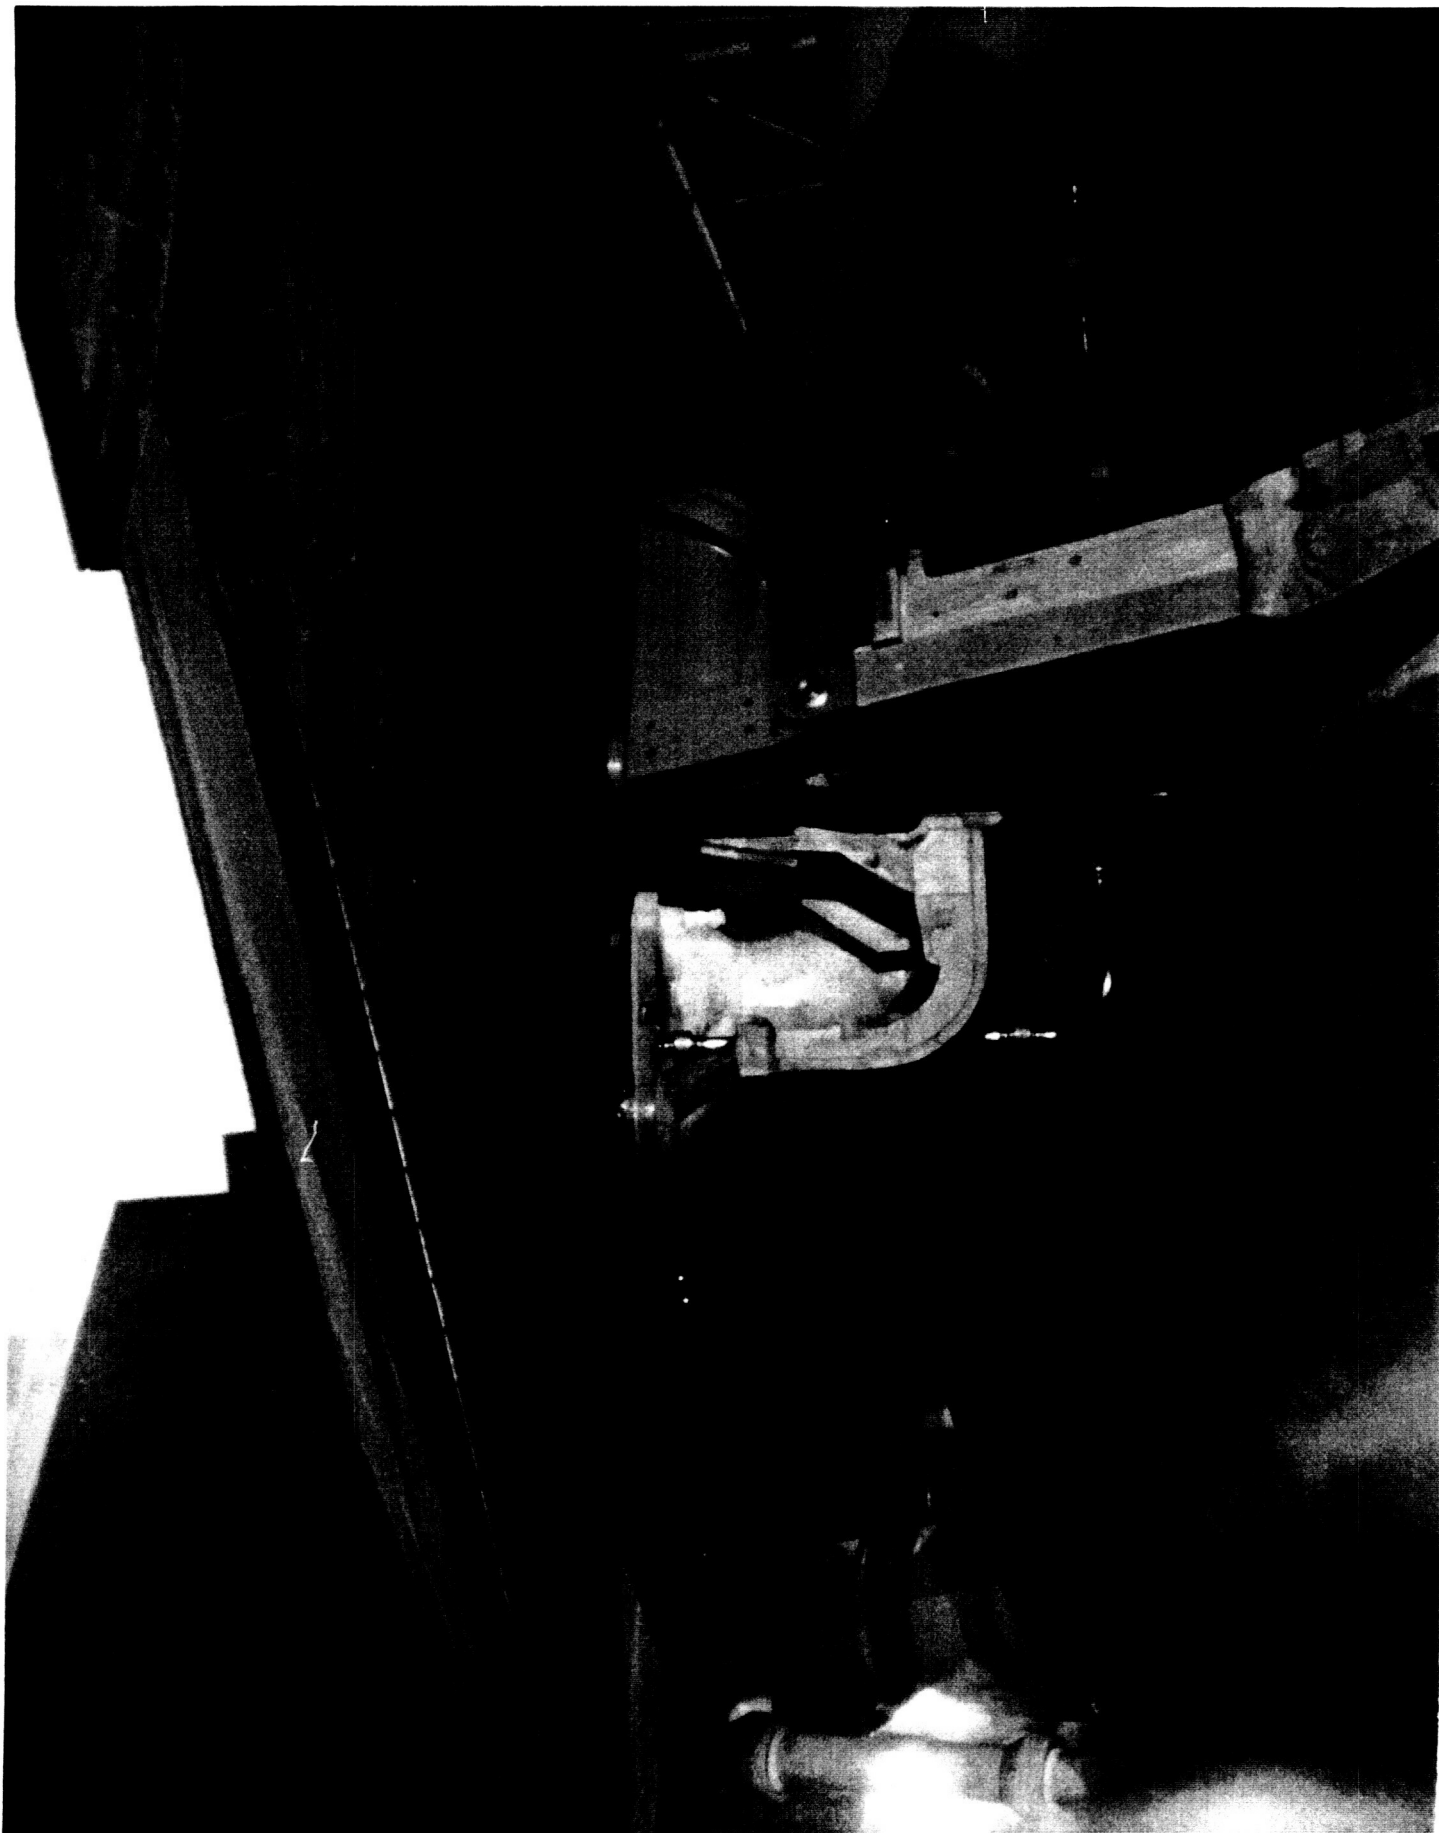
Frost fingers had formed on the ET/ORB LO2 umbilical purge vents, but ice/frost build-up on the umbilical acreage and in the cavities was less than usual.

ICE/FROST ON LO2 UMBILICAL PURGE VENT
AND OUTBOARD FORWARD SIDE OF BAGGIE

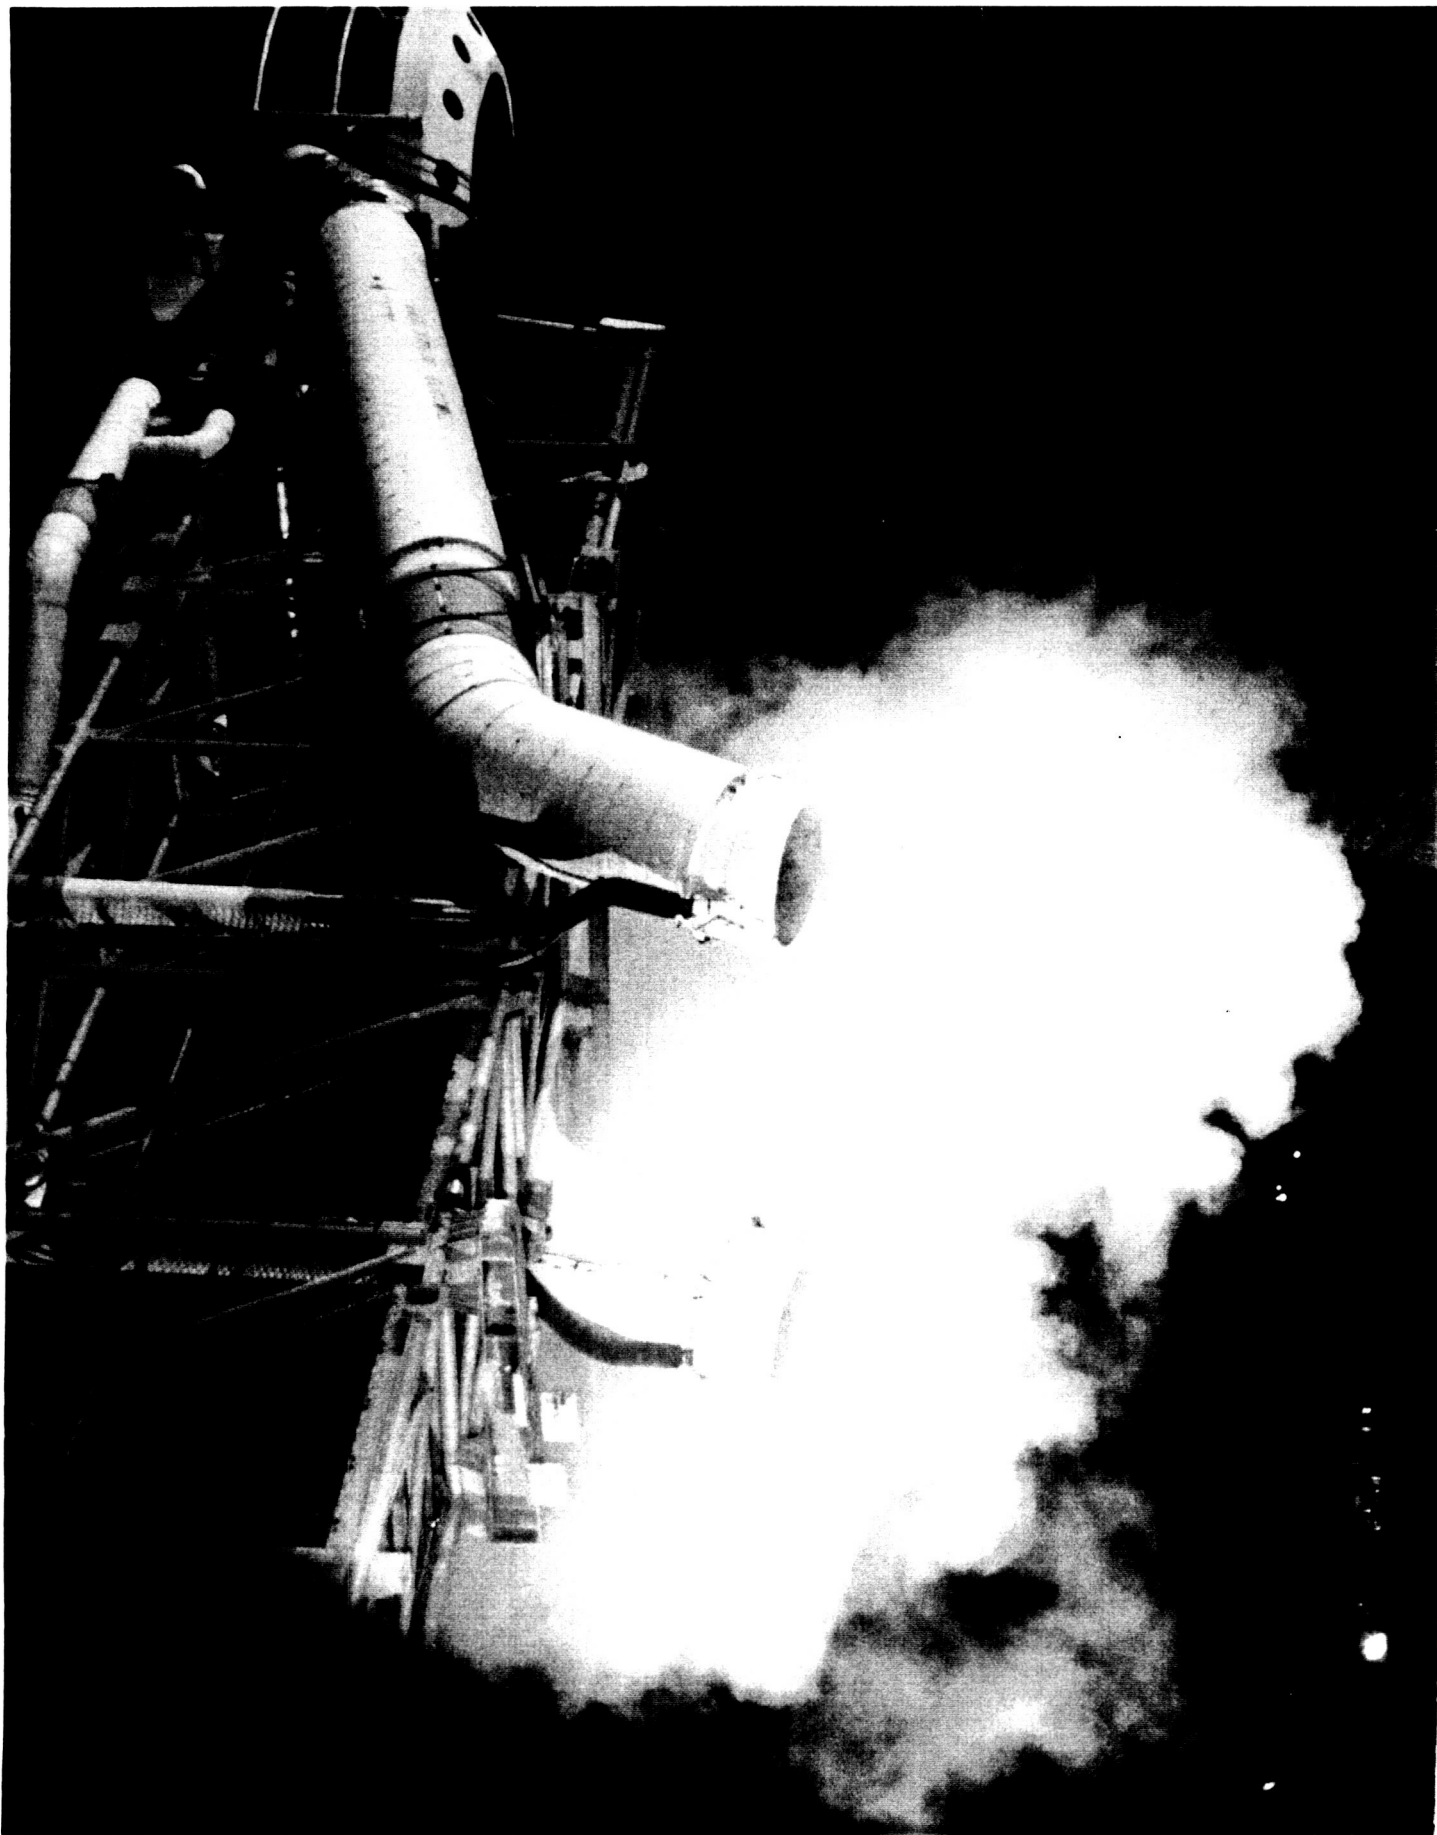
ALMOST EVEN VENTING DISTRIBUTION OF GOX VAPORS
NO ICE/FROST FORMATION ON GOX VENT EXHAUST DUCTS

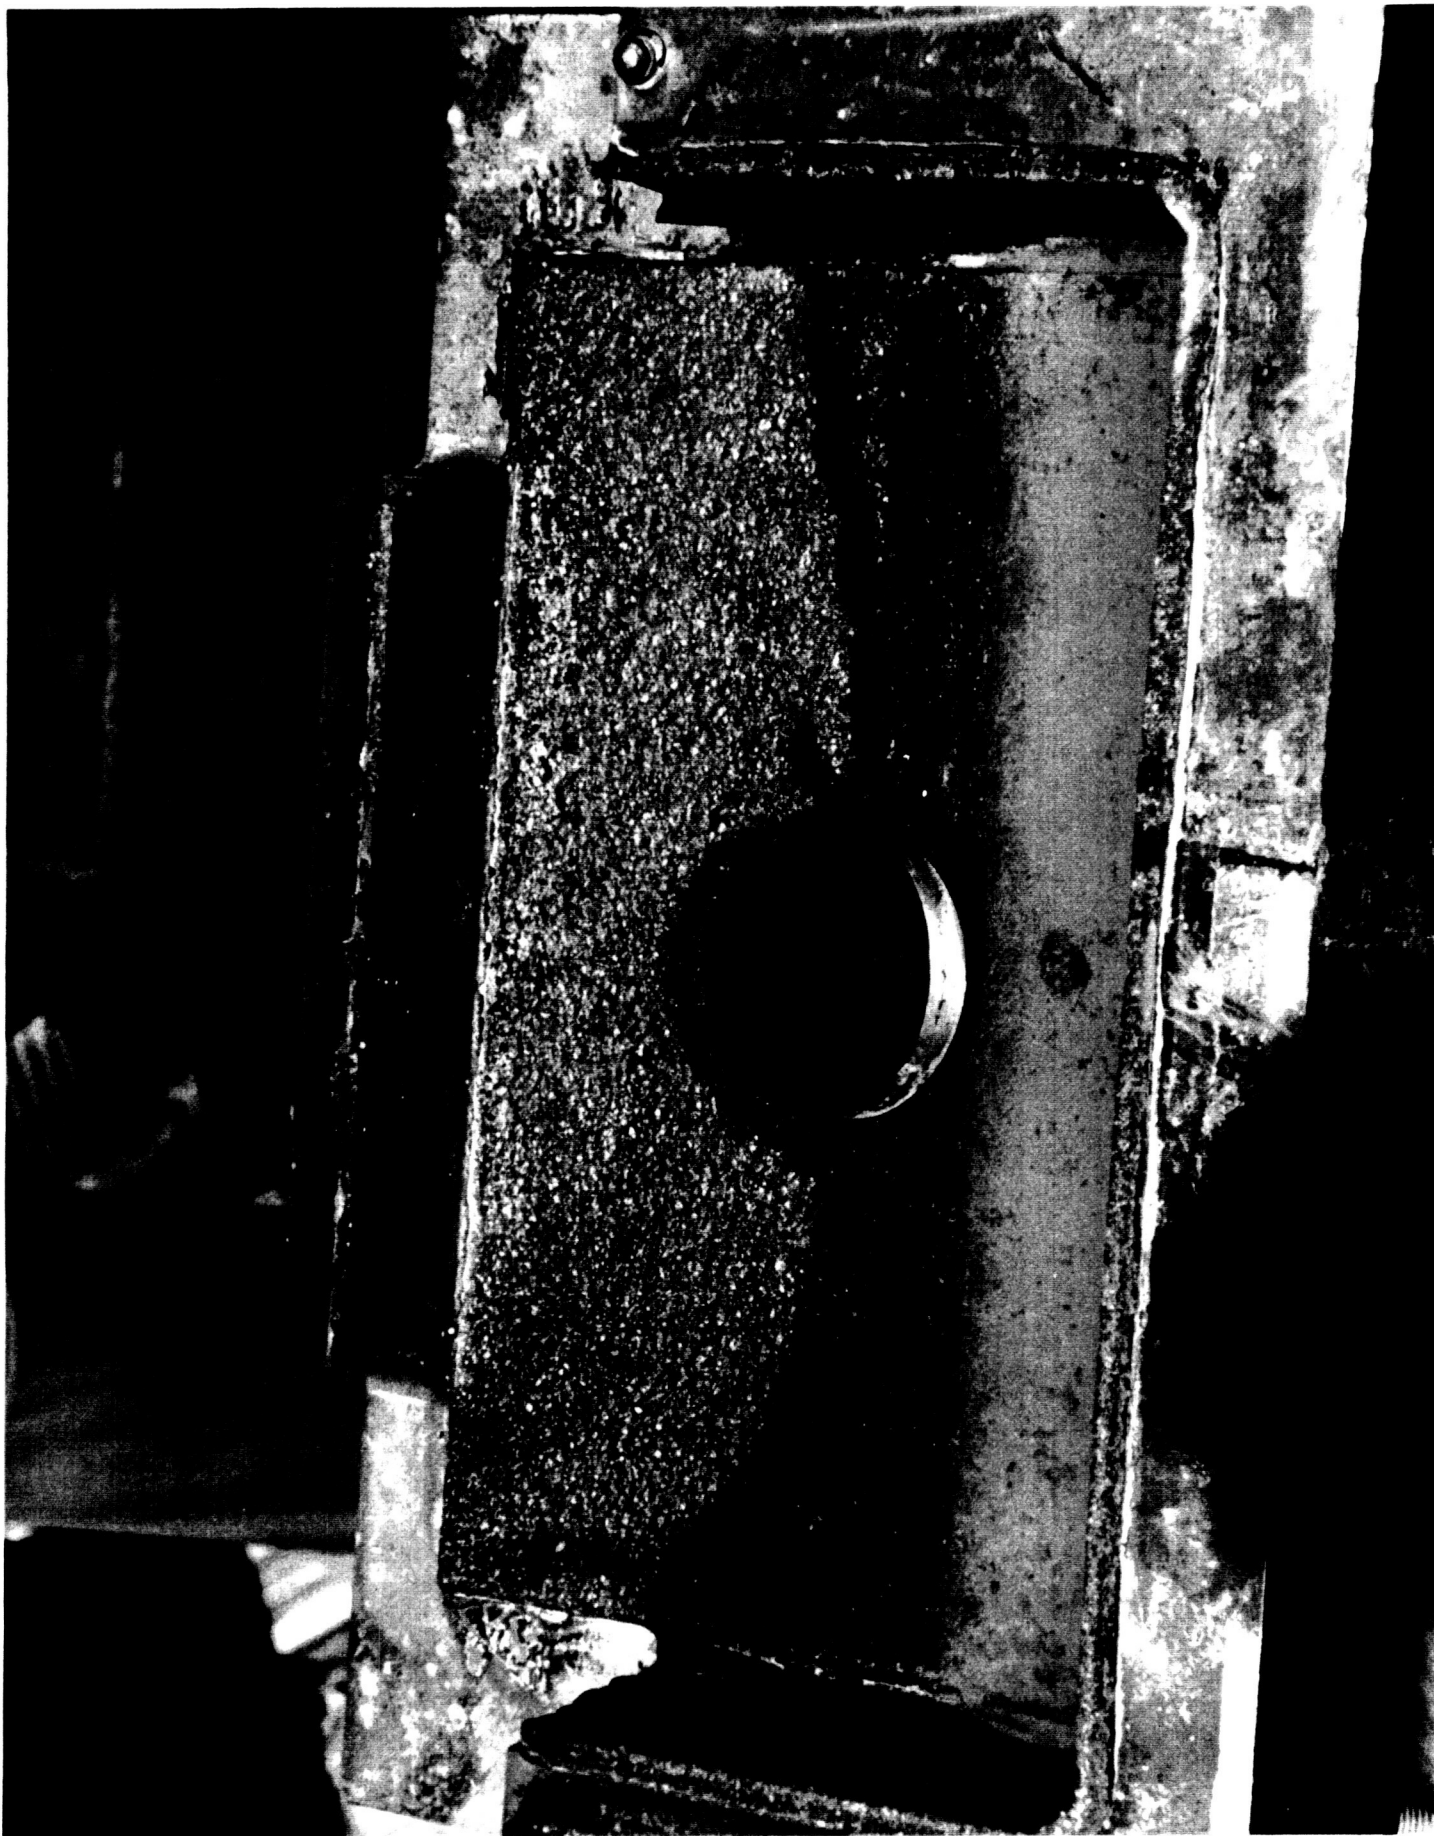
TYPICAL CONDITION OF SOUTH HOLDDOWN POST SHIM/SIDEWALL
MATERIAL AFTER LAUNCH

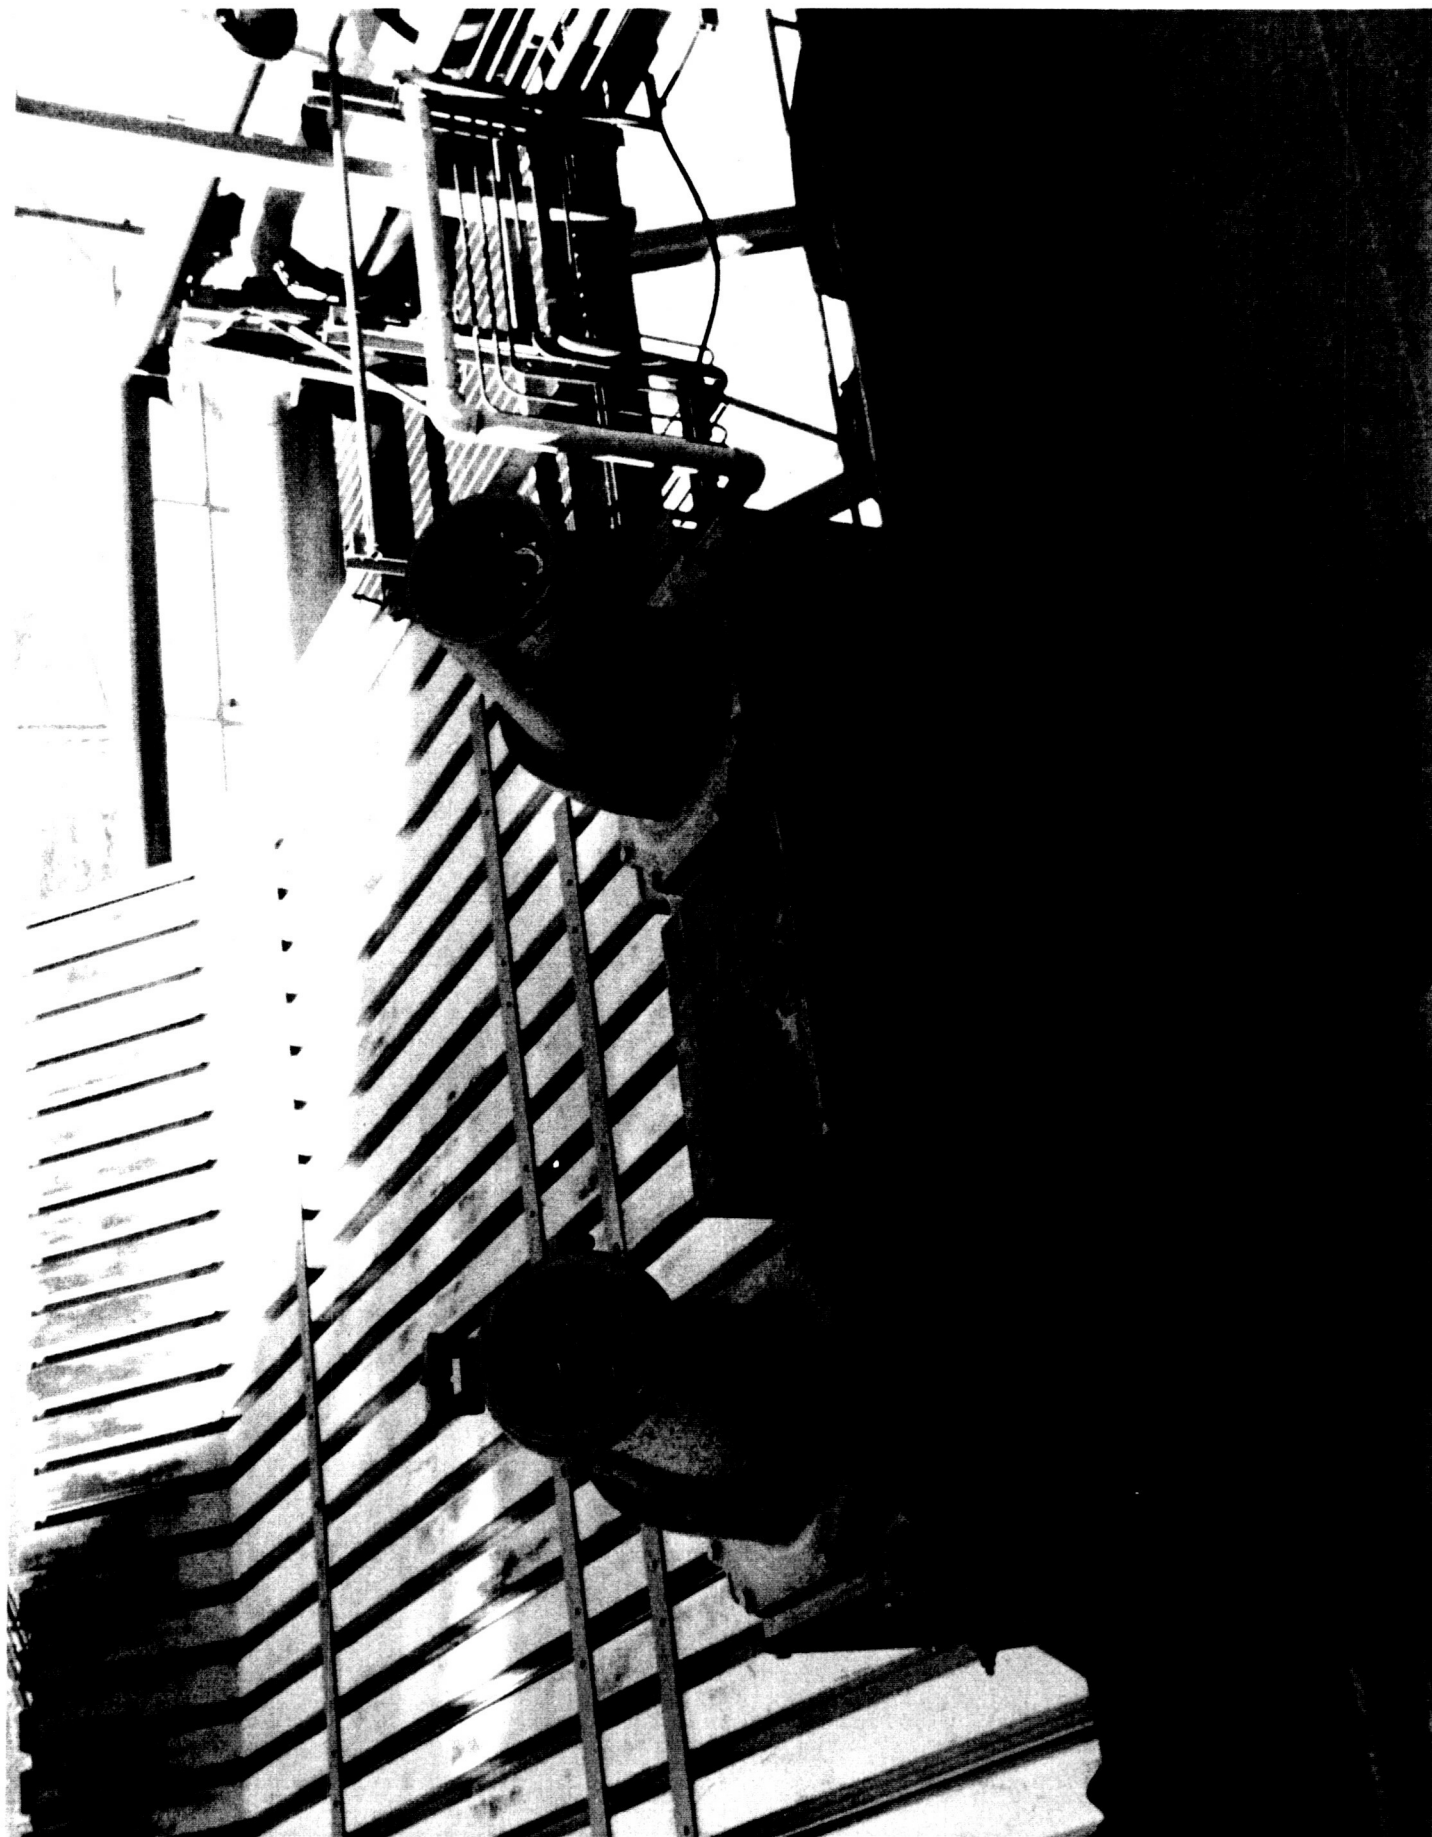
MISSING COVERS FROM MLP/PORTABLE PURGE UNIT INTERFACE
TERMINAL BOX AND ELECTRICAL RECEPTACLES

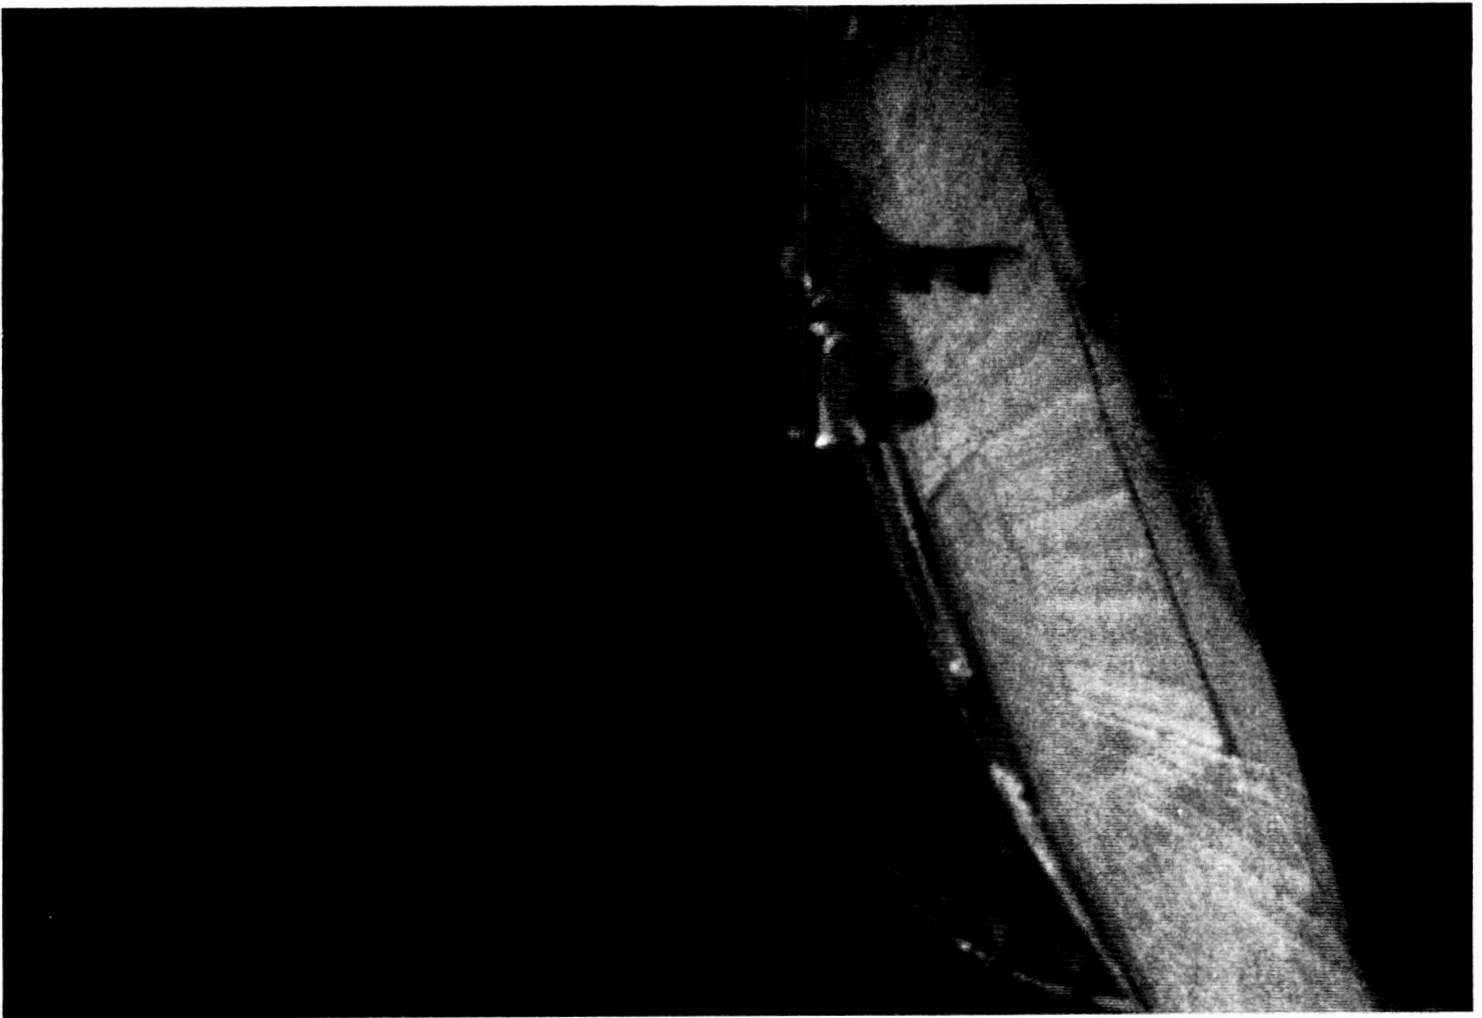
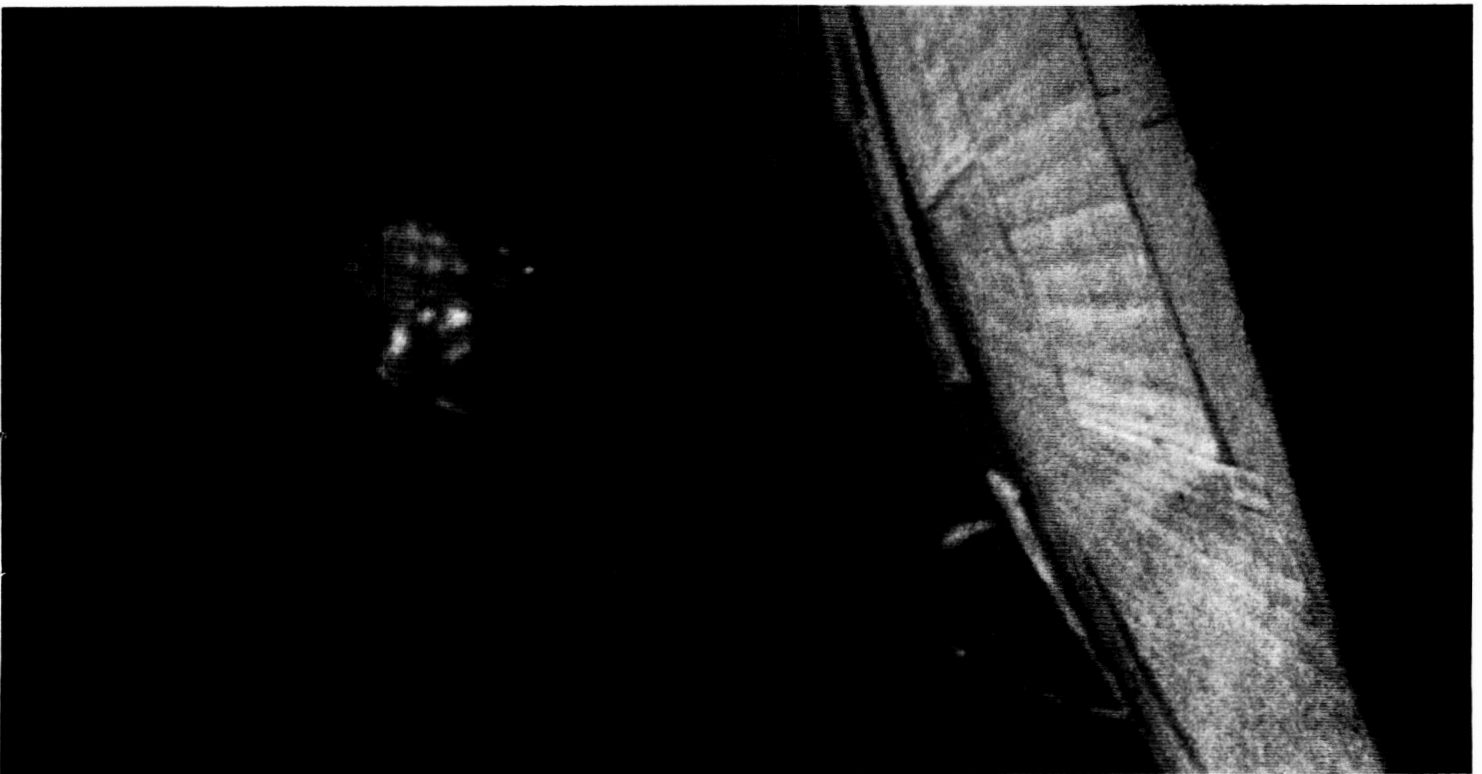
RED AND WHITE CHECKERED PAPER COVER COMES
LOOSE FROM ORBITER FORWARD RCS THRUSTER

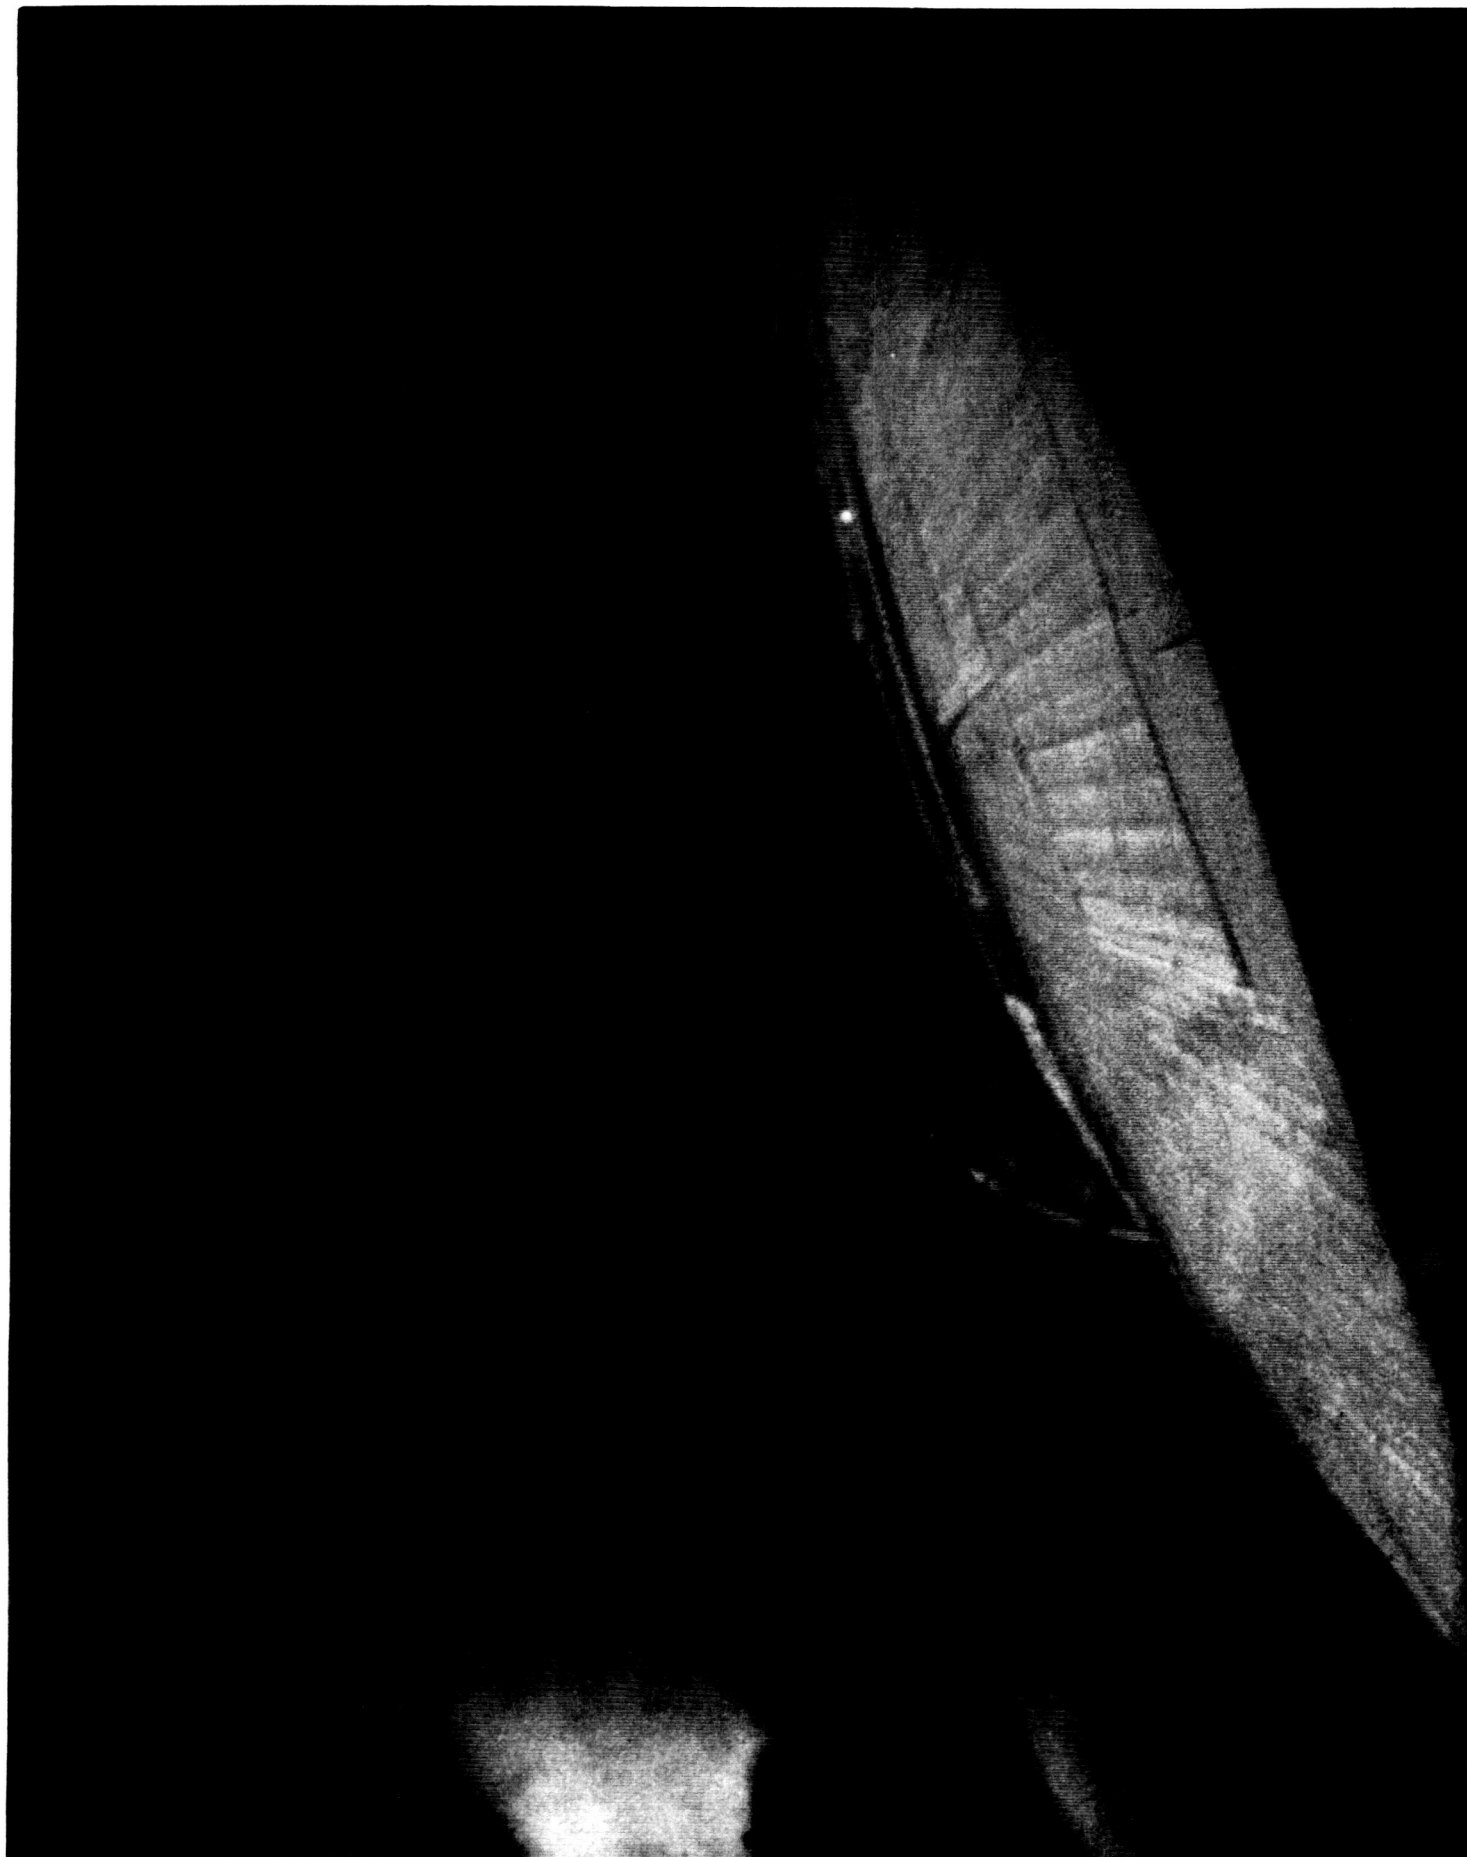
ORBITER FORWARD RCS PAPER COVER FELL AFT AND
CONTACTED WINDOW #4 LEAVING STREAKS OF RESIDUE

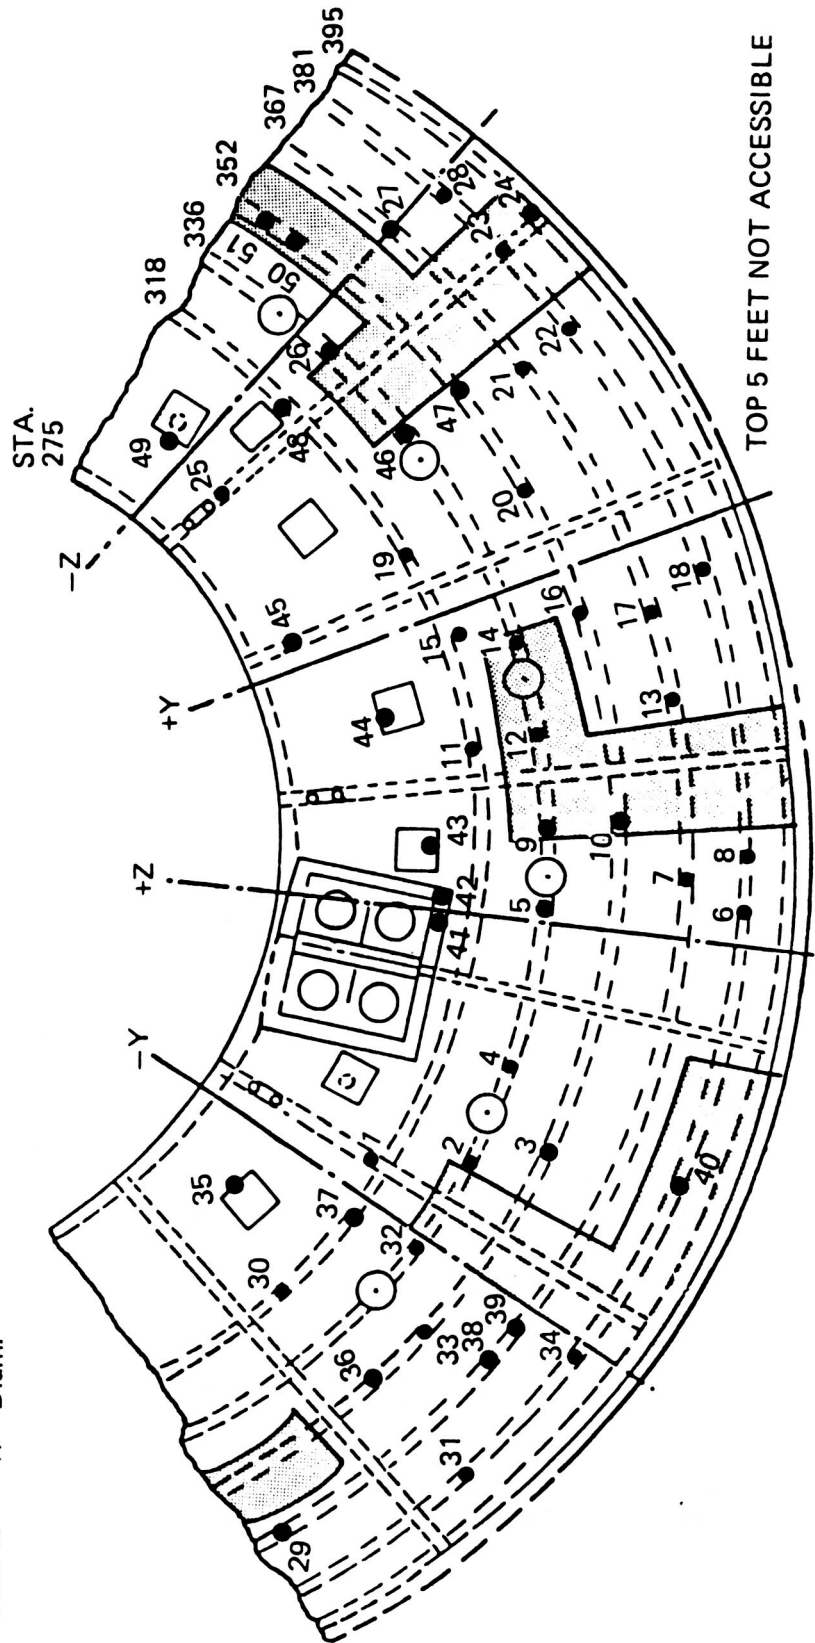
FIGURE 7. RIGHT SRB FRUSTUM

NOTE: Numerous Paint Blisters Ranging from $\frac{1}{4}$ " - $\frac{3}{4}$ " Diam.

DEBONDS
1. 3 x 2
2. 2 x 1½
3. 1½ x 1½
4. 1½ x 1½
5. 1½ x 1½
6. 2 x 1½
7. 3 x 1½
8. 2 x 2

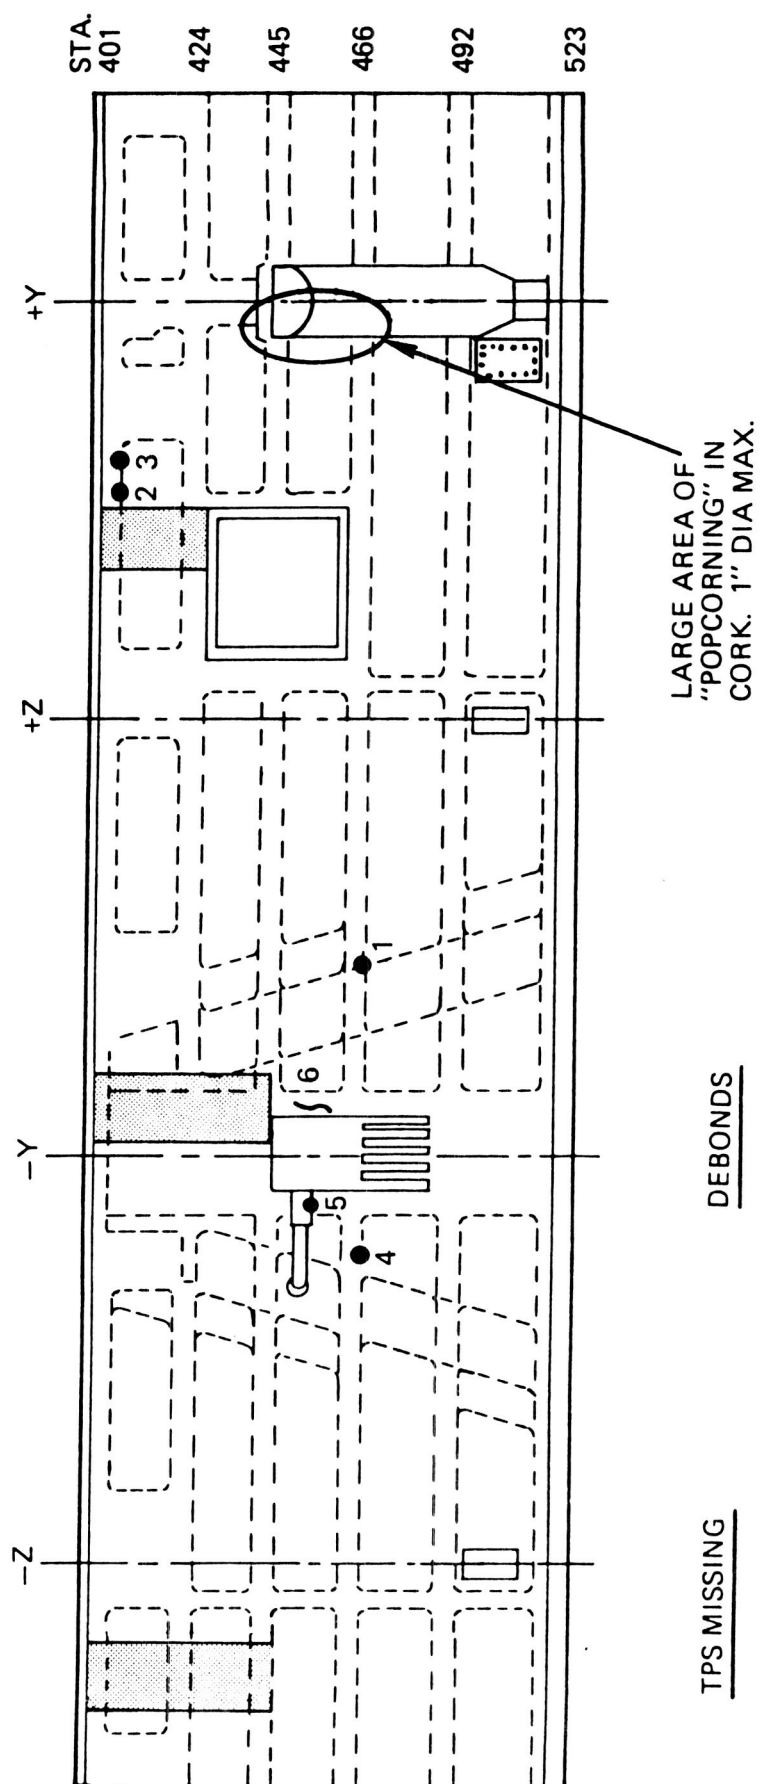
FIGURE 8. RIGHT SRB FWD SKIRT

<u>TPS MISSING</u>	<u>DEBONDS</u>
1. 1/2" DIA - Divot Occurred Prior to Launch	NONE
2. 1/4" x 1/4" MSA-2	
3. 1" x 1/2" MSA-2 MISSING TO SUBSTRATE	
4. 1/2" x 1/4" HYPALON BLISTER - MTA 2 MISSING	
5. 1/2" x 1 1/2" K5NA MISSING TO SUBSTRATE	
6. GOUGE IN MTA-2 WITH ADJACENT BLISTERING

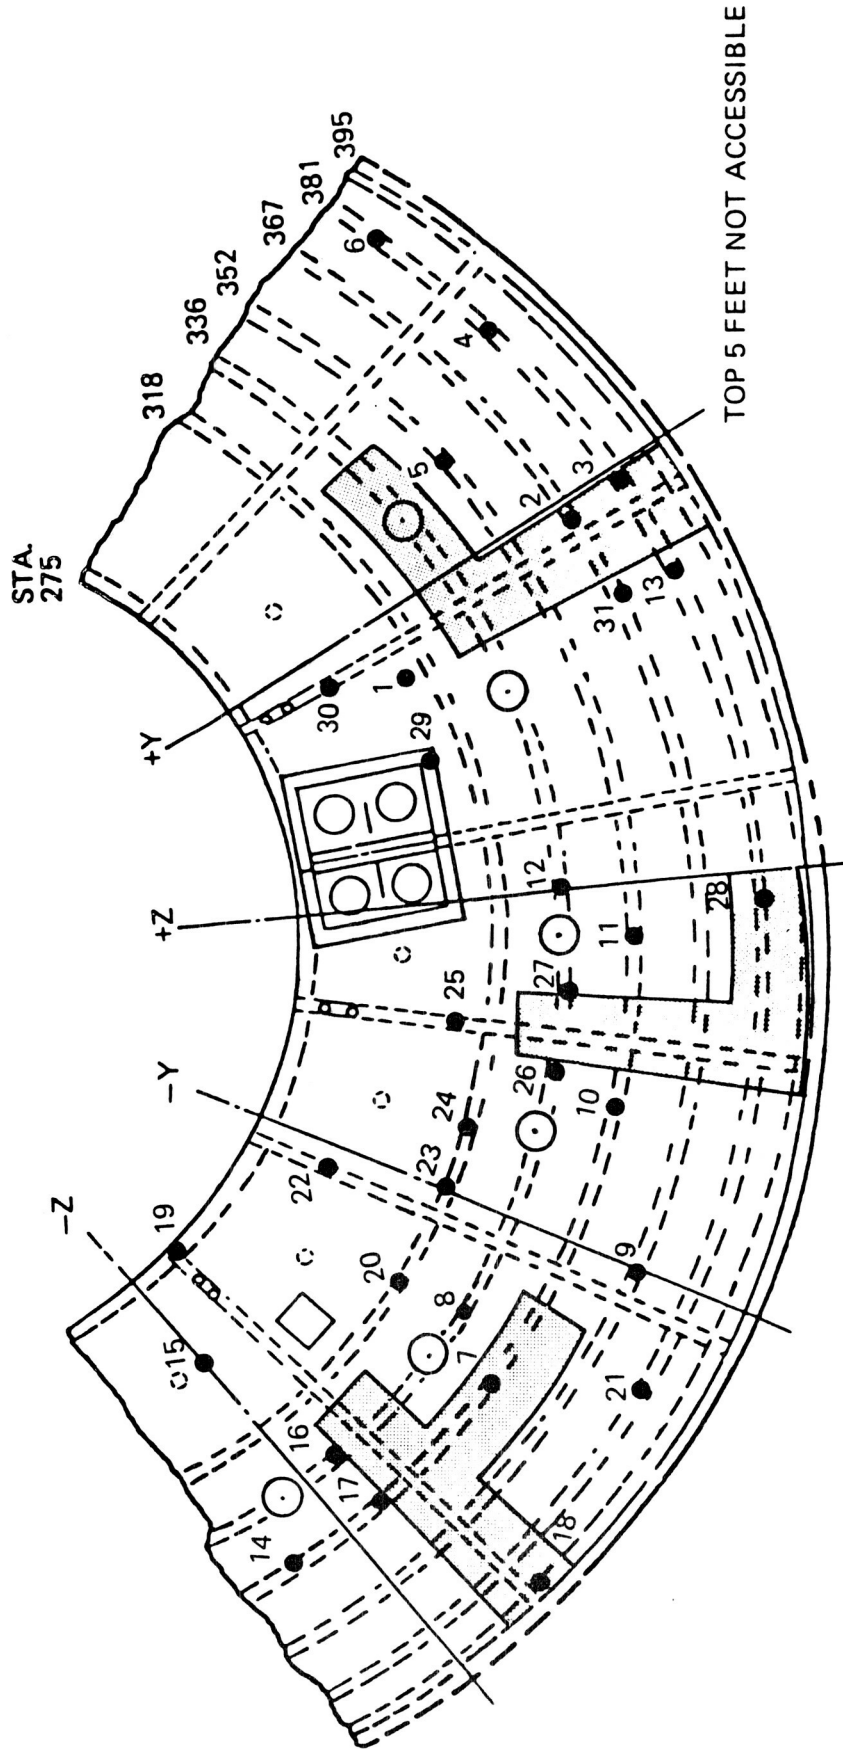
FIGURE 11. LEFT SRB FRUSTUM

NOTE: Numerous Paint Blisters On
 White Paint @ = 1/8" to 1/2" AVG
 Black Paint = 1/8" to 5"
